**Flood Control Project Maintenance
Levee Inspections**

Spring 2012 Levee Inspection Results

Reclamation District No. 0349 Sutter Island

Levee Inspection Report By Mile - Spring 2012

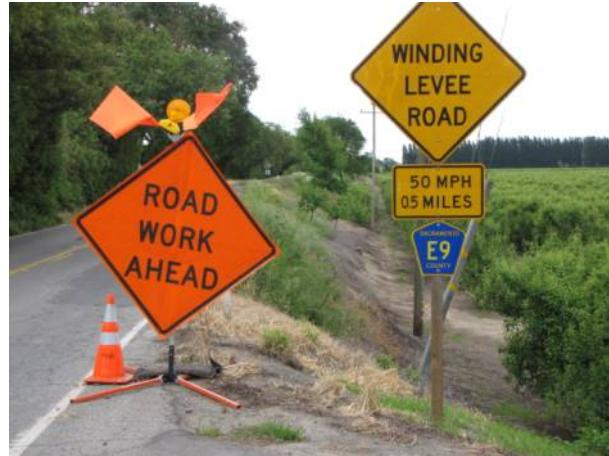
Levee Mile Report Line	4
Start Levee Mile	0.00
End Levee Mile	0.00
Location	Land Side
Category	Earthen Levee
Item	Vegetation
RD 349 Levee mile 0.00 looking downstream at landside slope. Photo taken 5-3-2012.	
phillips_s_20120511_416.jpg

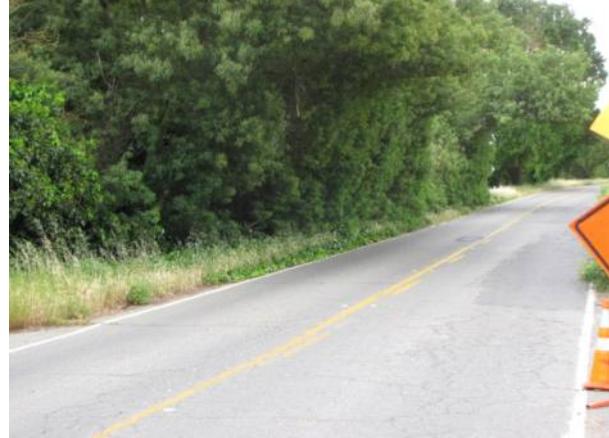
Levee Mile Report Line	5
Start Levee Mile	0.00
End Levee Mile	0.00
Location	Water Side
Category	Earthen Levee
Item	Vegetation
RD 349 Unit 1 looking downstream from levee mile 0.00 waterside. Unsatisfactory growth on waterward slope and shoulder. Cannot see levee section for over growth. Photo taken 5-3-2012.	
phillips_s_20120511_415.jpg

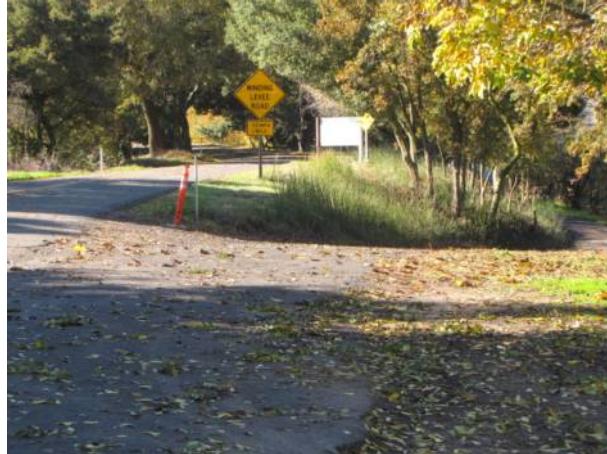
Levee Mile Report Line	1
Start Levee Mile	0.00
End Levee Mile	0.00
Location	Land Side
Category	Earthen Levee
Item	Vegetation
RD 349 This photo taken of levee mile 0.00 land side looking downstream of Unit 2. Photo taken 11-30-2011.	
phillips_s_20120306_102.jpg

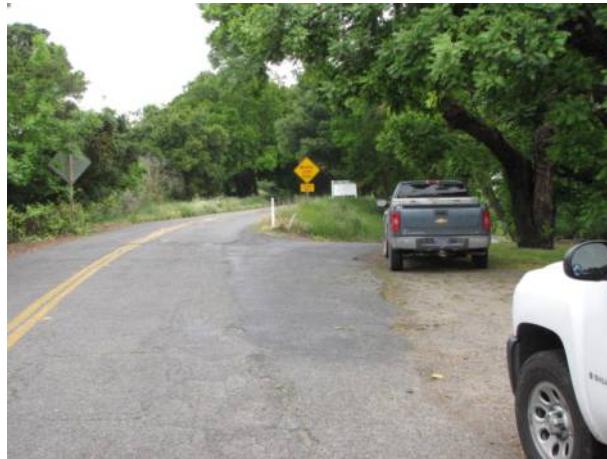
Levee Mile Report Line	1
Start Levee Mile	0.00
End Levee Mile	0.00
Location	Land Side
Category	Earthen Levee
Item	Vegetation
RD 349 Unit 2 looking downstream from levee mile 0.00 landside shoulder. Photo taken 5-3-2012.	
phillips_s_20120514_418.jpg

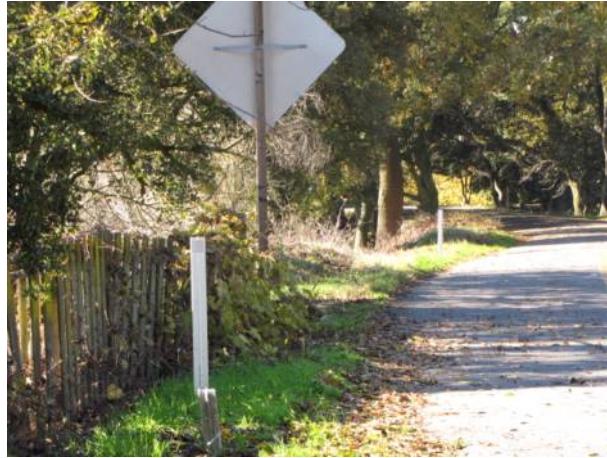
Levee Mile Report Line	2
Start Levee Mile	0.00
End Levee Mile	0.00
Location	Water Side
Category	Earthen Levee
Item	Vegetation
RD 349 Unit 2 looking downstream water side. Photo taken 11-30-2011.	
phillips_s_20120306_103.jpg

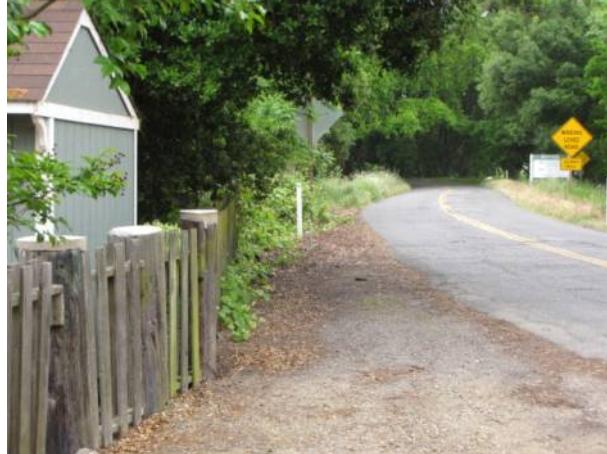
Levee Mile Report Line	2
Start Levee Mile	0.00
End Levee Mile	0.00
Location	Water Side
Category	Earthen Levee
Item	Vegetation
RD 349 Unit 2 levee mile 0.00 looking downstream from waterside. Photo taken 5-3-2012.	
phillips_s_20120514_417.jpg

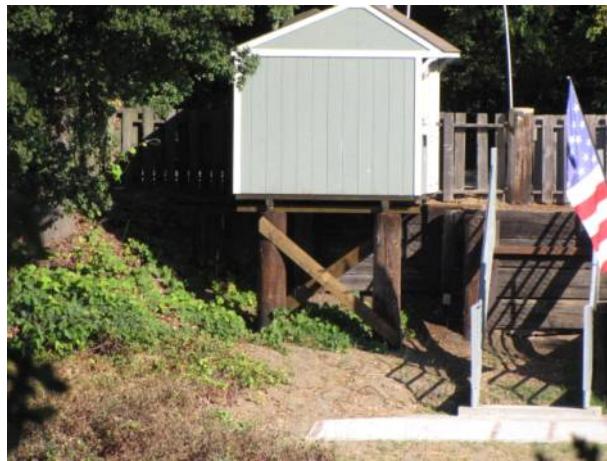
Levee Mile Report Line	3
Start Levee Mile	0.02
End Levee Mile	0.02
Location	Water Side
Category	Earthen Levee
Item	Encroachments
This is the view from across the channel of a building sitting on pilings waterside.	
phillips_s_20120306_093.jpg

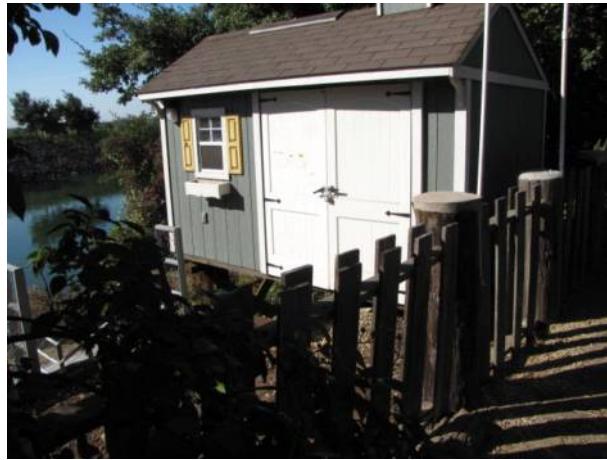
Levee Mile Report Line	3
Start Levee Mile	0.02
End Levee Mile	0.02
Location	Water Side
Category	Earthen Levee
Item	Encroachments
Unauthorized building on waterside levee mile 0.02 RD 349 Unit 2.	
phillips_s_20120306_094.jpg

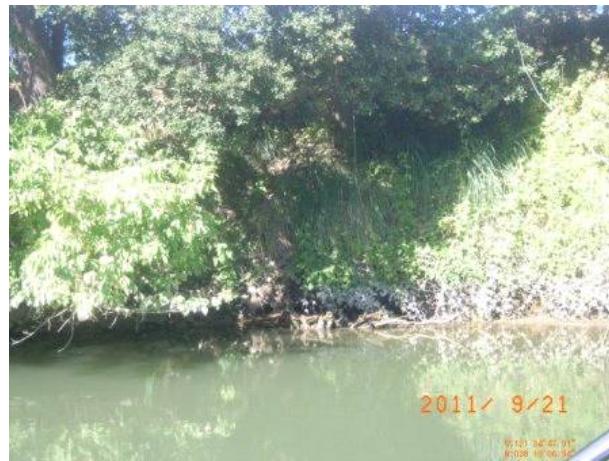
USACE 2011 Photo #1

Levee Mile Report Line	8
Start Levee Mile	0.18
End Levee Mile	0.29
Location	Water Side
Category	Supplemental
Item	USACE Erosion Survey

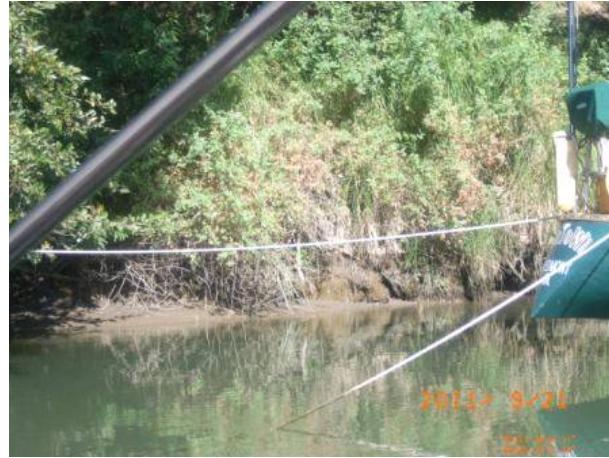
USACE 2011 Photo #2

Levee Mile Report Line	8
Start Levee Mile	0.18
End Levee Mile	0.29
Location	Water Side
Category	Supplemental
Item	USACE Erosion Survey

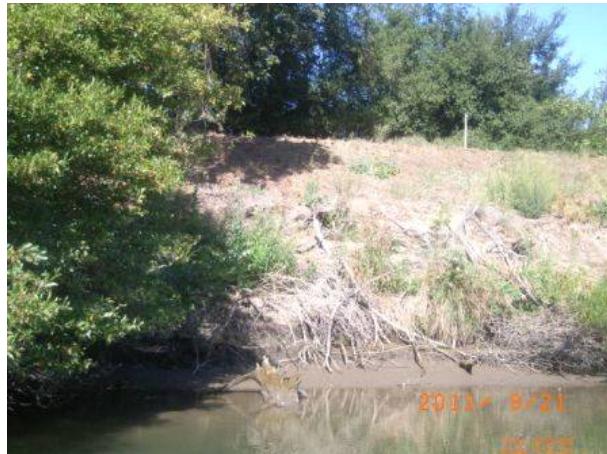
USACE 2011 Photo #2

Levee Mile Report Line	10
Start Levee Mile	0.54
End Levee Mile	0.59
Location	Water Side
Category	Supplemental
Item	USACE Erosion Survey

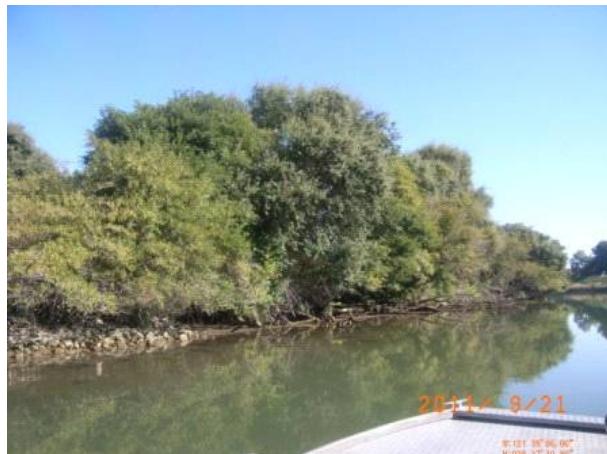
USACE 2011 Photo #1

Levee Mile Report Line	17
Start Levee Mile	1.32
End Levee Mile	1.33
Location	Water Side
Category	Supplemental
Item	USACE Erosion Survey

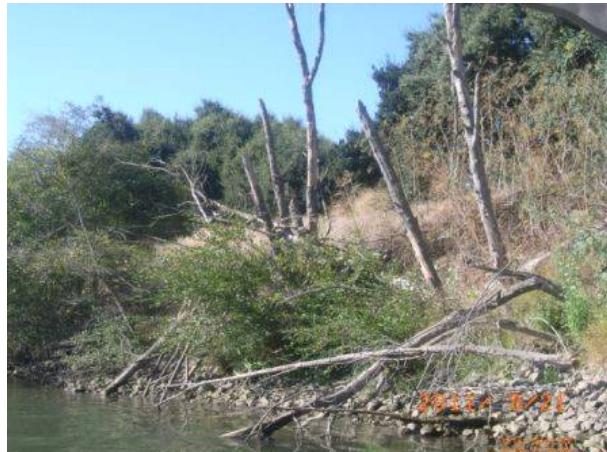
USACE 2011 Photo #3

Levee Mile Report Line	17
Start Levee Mile	1.32
End Levee Mile	1.33
Location	Water Side
Category	Supplemental
Item	USACE Erosion Survey

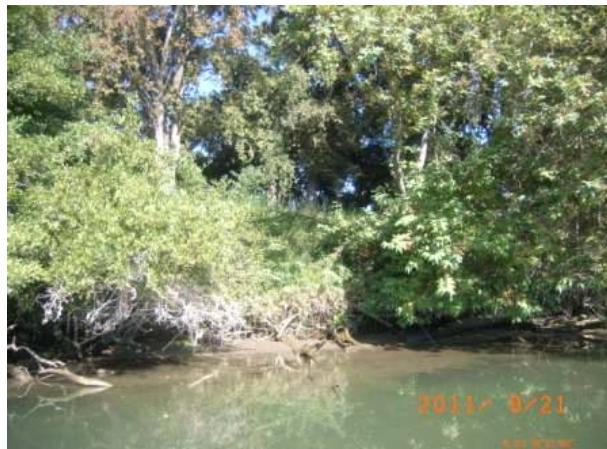
USACE 2011 Photo #1

Levee Mile Report Line	21
Start Levee Mile	2.00
End Levee Mile	2.05
Location	Water Side
Category	Supplemental
Item	USACE Erosion Survey

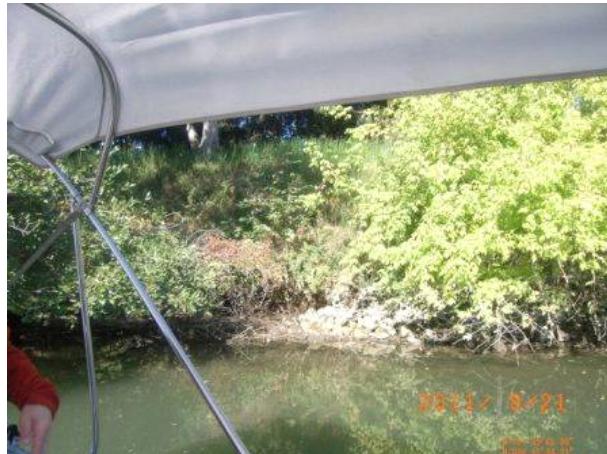
USACE 2011 Photo #3

Levee Mile Report Line	21
Start Levee Mile	2.00
End Levee Mile	2.05
Location	Water Side
Category	Supplemental
Item	USACE Erosion Survey

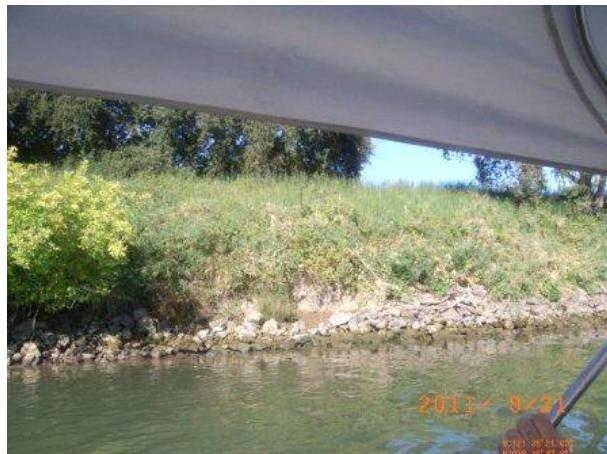
USACE 2011 Photo #1

22	2.05	2.05	Supplemental USACE Erosion Survey	WS	M Ma	Inspector Comments: 2011: Small scallop caused by erosion and wavewash. [2011 Site ID: STM_24-1_R]			38.280069 °	38.279919 °	30	-121.589443 ° -121.589438 ° Y DWR ID: DWR_RD0349_02_s_2012_30
23	2.16	2.16	Earthen Levee	Encroachments	WS	M En	PI : Pipe Inspector Comments: Abandoned pipe on waterward slope. At this location there is an irrigation pipe sleeved through another pipe (12-inch) with annular spaces not grouted. Photo taken 11-30-2011.	38.278694 °	38.278694 °	19	-121.590067 ° -121.590067 ° Y DWR ID: DWR_RD0349_02_s_2012_19	
24	2.16	2.16	Earthen Levee	Encroachments	LS	U En	PI : Pipe Inspector Comments: Unauthorized pipe (PVC) through levee section. Opened pipe through the levee section is not authorized. Annular space inside pipe should be grouted.	38.278694 °	38.278694 °	15	-121.590070 ° -121.590070 ° Y DWR ID: DWR_RD0349_02_s_2012_15

Levee Mile Report Line	22
Start Levee Mile	2.05
End Levee Mile	2.05
Location	Water Side
Category	Supplemental
Item	USACE Erosion Survey

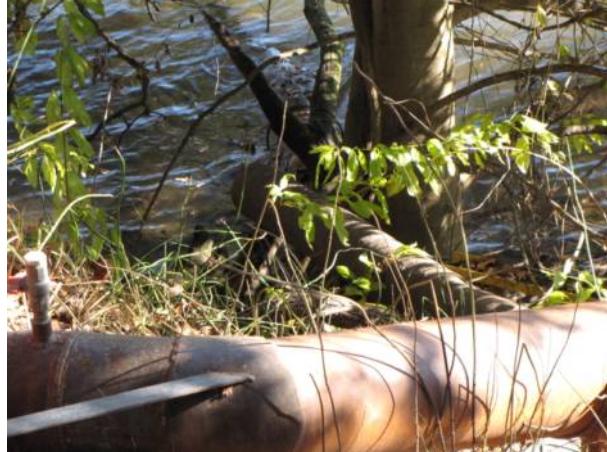
Levee Mile Report Line	23
Start Levee Mile	2.16
End Levee Mile	2.16
Location	Water Side
Category	Earthen Levee
Item	Encroachments
Discarded pipe waterward toe. Photo taken 11-30-2011.	
phillips_s_20120306_101.jpg

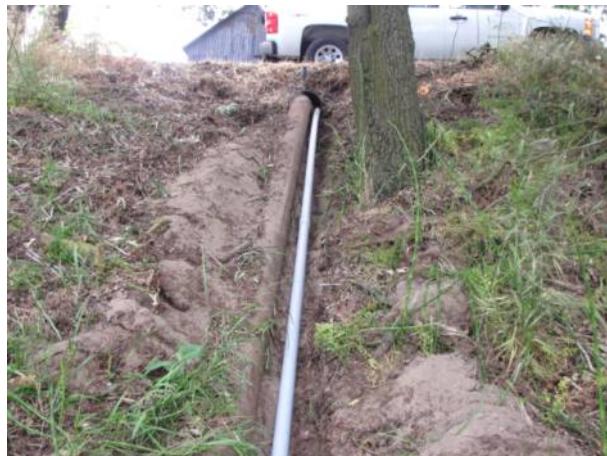
Levee Mile Report Line	24
Start Levee Mile	2.16
End Levee Mile	2.16
Location	Land Side
Category	Earthen Levee
Item	Encroachments
View from landward at unauthorized pipe installation at levee mile 2.13. Photo taken 5-23-2011	
phillips_s_20120306_097.jpg

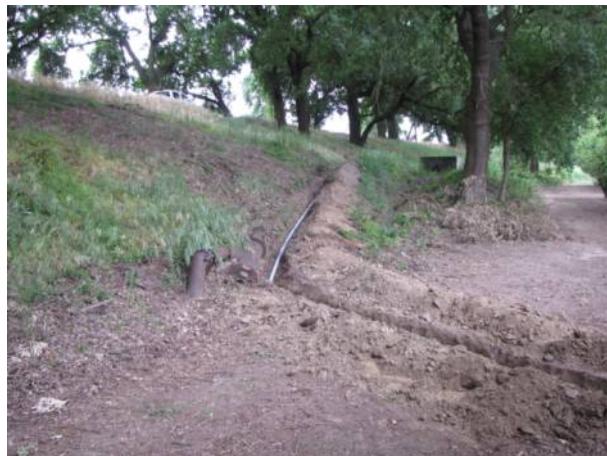
Levee Mile Report Line	24
Start Levee Mile	2.16
End Levee Mile	2.16
Location	Land Side
Category	Earthen Levee
Item	Encroachments
View from landside of unauthorized pipe installation. Photo taken 5-23-2011	
phillips_s_20120306_098.jpg

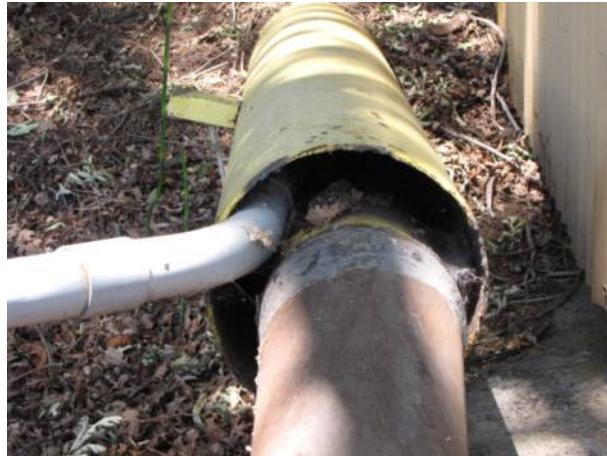
Levee Mile Report Line	24
Start Levee Mile	2.16
End Levee Mile	2.16
Location	Land Side
Category	Earthen Levee
Item	Encroachments
Aunauthorized open pipe through the levee section. Photo taken 5-3-2012.	
phillips_s_20120521_419.jpg

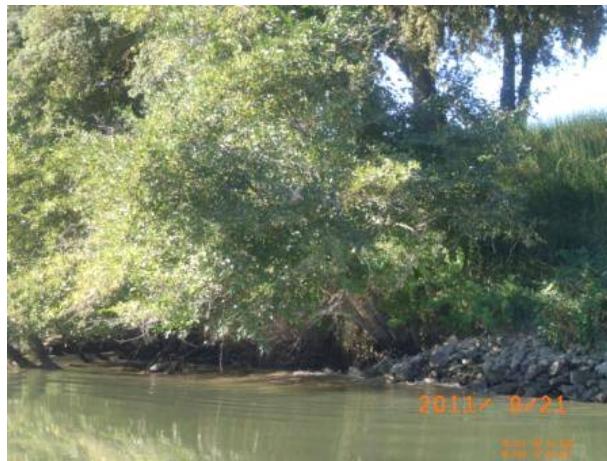
Levee Mile Report Line	27
Start Levee Mile	2.46
End Levee Mile	2.66
Location	Water Side
Category	Supplemental
Item	USACE Erosion Survey
USACE 2011 Photo #1	
phillips_s_20120306_115.jpg

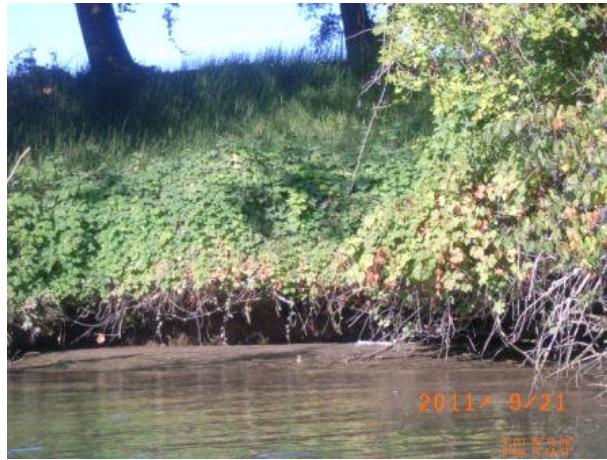
Levee Mile Report Line	27
Start Levee Mile	2.46
End Levee Mile	2.66
Location	Water Side
Category	Supplemental
Item	USACE Erosion Survey
USACE 2011 Photo #2	
phillips_s_20120306_116.jpg

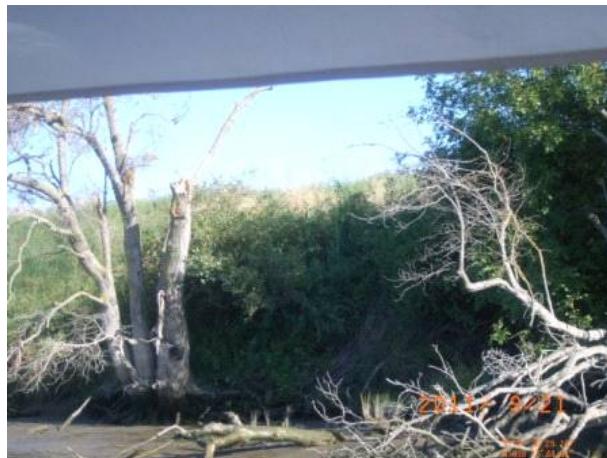
USACE 2011 Photo #2

Levee Mile Report Line	30
Start Levee Mile	3.25
End Levee Mile	3.47
Location	Water Side
Category	Supplemental
Item	USACE Erosion Survey

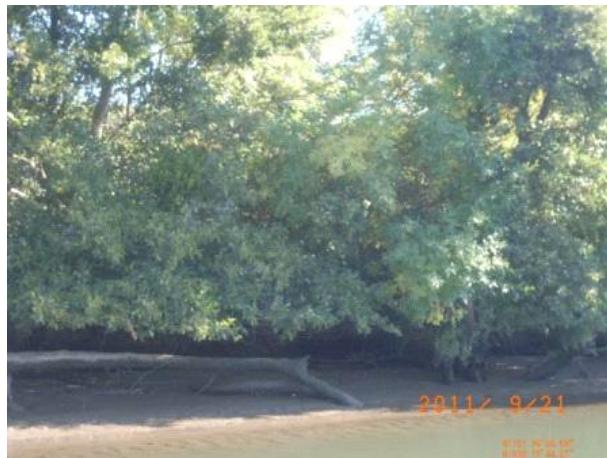
USACE 2011 Photo #3

Levee Mile Report Line	30
Start Levee Mile	3.25
End Levee Mile	3.47
Location	Water Side
Category	Supplemental
Item	USACE Erosion Survey

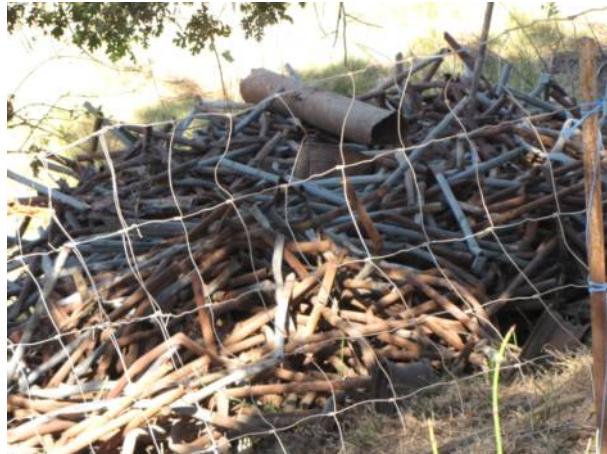
Levee Mile Report Line	31
Start Levee Mile	3.39
End Levee Mile	3.40
Location	Land Side
Category	Earthen Levee
Item	Encroachments
Old pipe stocked on land ward slope unit 2 levee mile 3.39-3.40.	
phillips_s_20120306_092.jpg

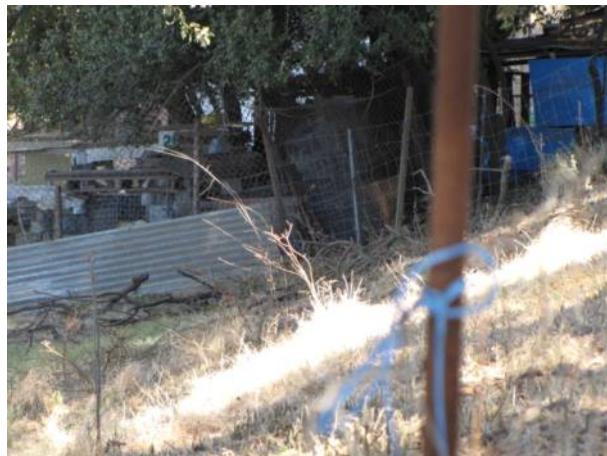
Levee Mile Report Line	37
Start Levee Mile	3.75
End Levee Mile	3.77
Location	Land Side
Category	Earthen Levee
Item	Encroachments
This photo shows a fence at right bottom and the tin in back ground is part of another pen. The top right side of photo shows the corner of a building of slope. The equipment is shown in backside of fence.	
phillips_s_20120306_121.jpg

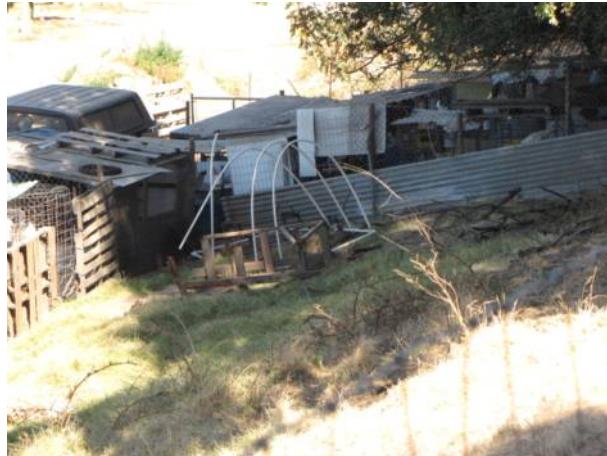
Levee Mile Report Line	37
Start Levee Mile	3.75
End Levee Mile	3.77
Location	Land Side
Category	Earthen Levee
Item	Encroachments
This photo shows the material on slope along with cages for goats and chickens.	
phillips_s_20120306_122.jpg

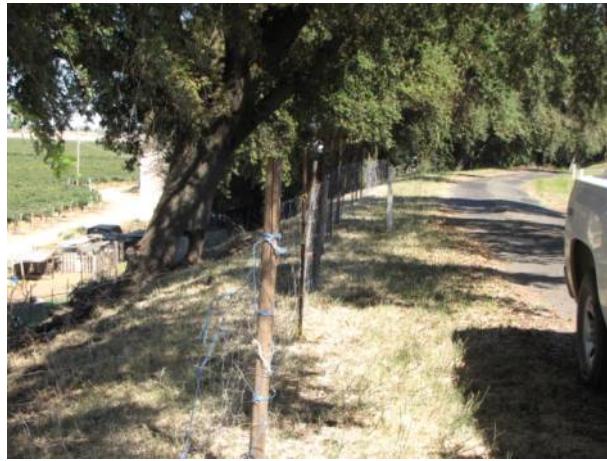
Levee Mile Report Line	39
Start Levee Mile	3.78
End Levee Mile	3.78
Location	Land Side
Category	Earthen Levee
Item	Encroachments
This fence has no permit, the landowner moves it from time to time. He keeps goats inside of it..	
phillips_s_20120306_123.jpg

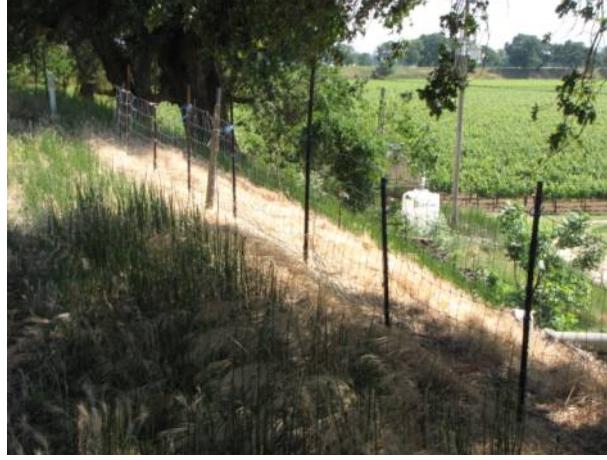
Levee Mile Report Line	40
Start Levee Mile	3.80
End Levee Mile	3.84
Location	Land Side
Category	Earthen Levee
Item	Encroachments
Unauthorized fence remains on levee slope landward levee mile 3.80-3.84. Photo taken 5-23-2011.	
phillips_s_20120306_099.jpg

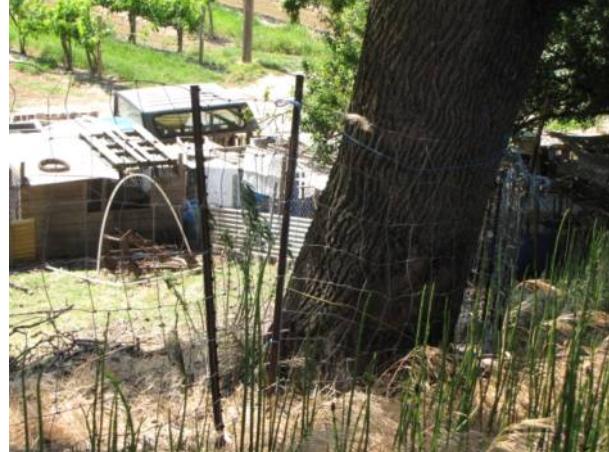
Levee Mile Report Line	40
Start Levee Mile	3.80
End Levee Mile	3.84
Location	Land Side
Category	Earthen Levee
Item	Encroachments
View of fence and other structures at toe of levee section. Photo taken 5-23-2011.	
phillips_s_20120306_100.jpg

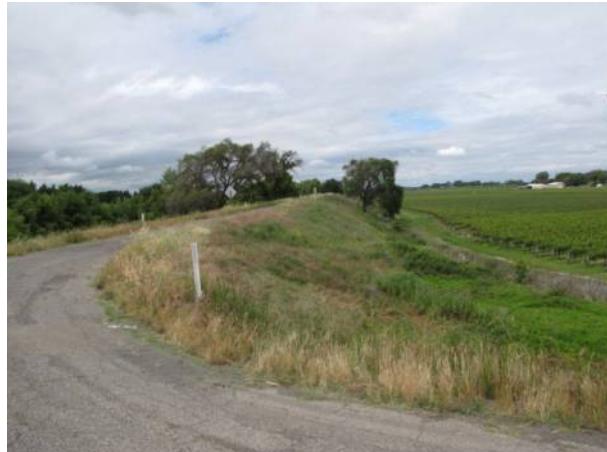
Levee Mile Report Line	1
Start Levee Mile	0.00
End Levee Mile	0.00
Location	Water Side
Category	Earthen Levee
Item	Vegetation
RD 349 Unit 3 levee mile 0.00 looking downstream of the landside slope. Photo taken 5-3-2012.	
phillips_s_20120514_419.jpg

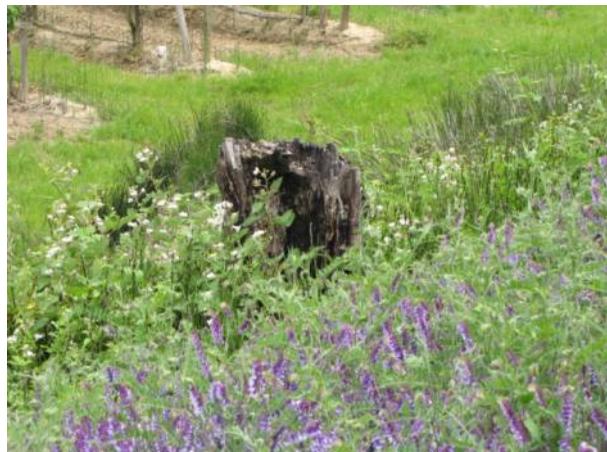
Levee Mile Report Line	6
Start Levee Mile	0.62
End Levee Mile	0.62
Location	Land Side
Category	Earthen Levee
Item	Trim / Thin Trees
This stump is located on the landward slope.	
phillips_s_20120306_127.jpg

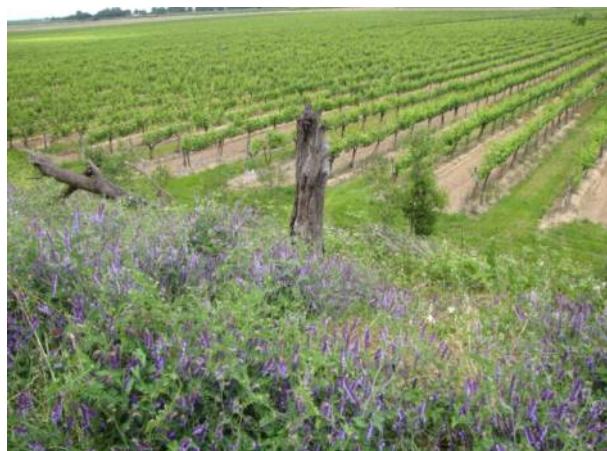
Levee Mile Report Line	7
Start Levee Mile	0.63
End Levee Mile	0.63
Location	Land Side
Category	Earthen Levee
Item	Trim / Thin Trees
Broken tree with stump on landward slope, broken top portion of this tree is resting on the landward toe. District is aware of this encroachment.	
phillips_s_20120306_126.jpg

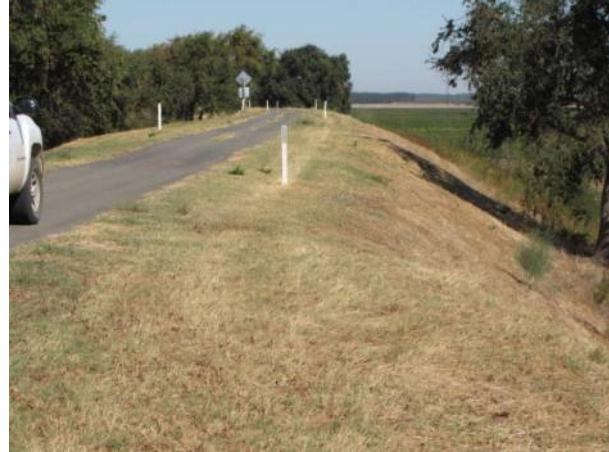
Levee Mile Report Line	10
Start Levee Mile	0.81
End Levee Mile	0.81
Location	Land Side
Category	Earthen Levee
Item	Encroachments
Unit 3 levee mile 0.00 land side looking down stream.	
phillips_s_20120306_124.jpg

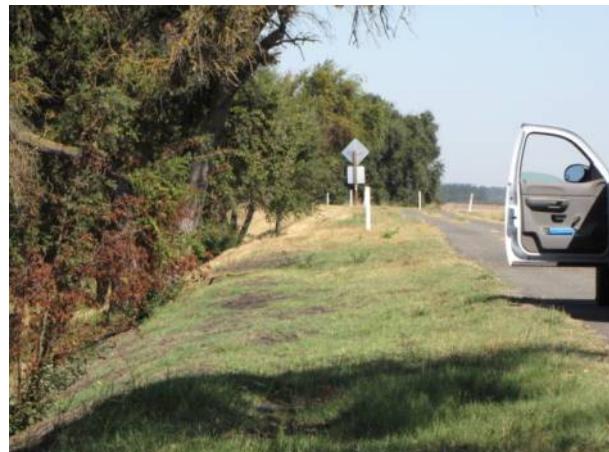
Levee Mile Report Line	10
Start Levee Mile	0.81
End Levee Mile	0.81
Location	Land Side
Category	Earthen Levee
Item	Encroachments
Unit 3 water side looking downstream RD 349.	
phillips_s_20120306_125.jpg

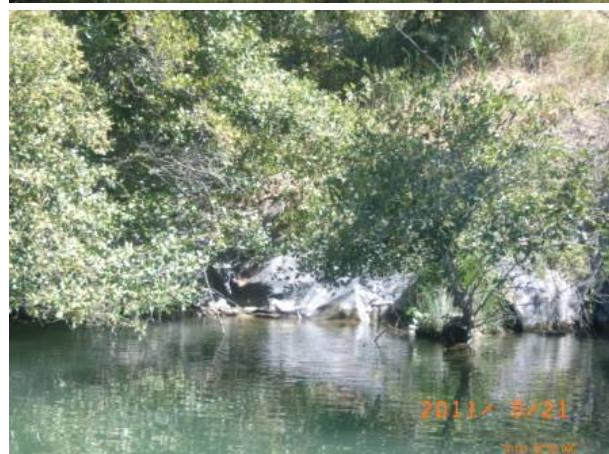
Levee Mile Report Line	14
Start Levee Mile	2.20
End Levee Mile	2.20
Location	Water Side
Category	Supplemental
Item	USACE Erosion Survey
USACE 2011 Photo #1	
phillips_s_20120306_131.jpg

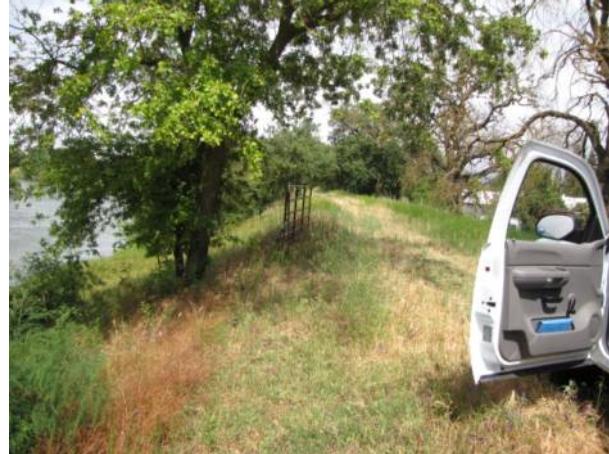
Levee Mile Report Line	22
Start Levee Mile	5.13
End Levee Mile	5.31
Location	Land Side
Category	Earthen Levee
Item	Vegetation
Another view of wild growth on levee section looking downstream. Photo taken 5-23-2011.	
phillips_s_20120306_134.jpg

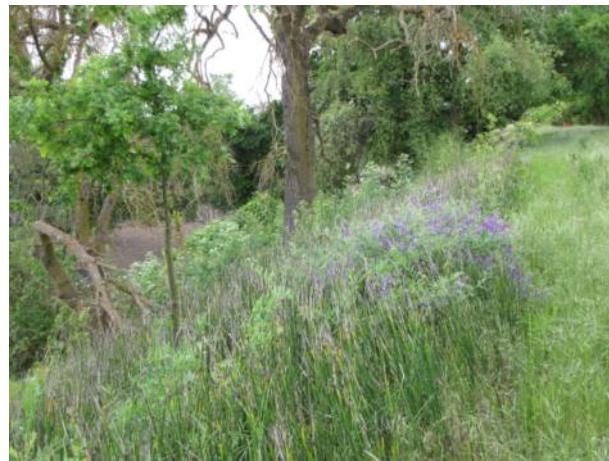
Levee Mile Report Line	25
Start Levee Mile	5.40
End Levee Mile	5.40
Location	Land Side
Category	Earthen Levee
Item	Vegetation
RD 349 Unit 3 Levee mile 5.40 looking upstream landward unsatisfactory growth on slope and shoulders. 5-03-2012.	
phillips_s_20120515_420.jpg

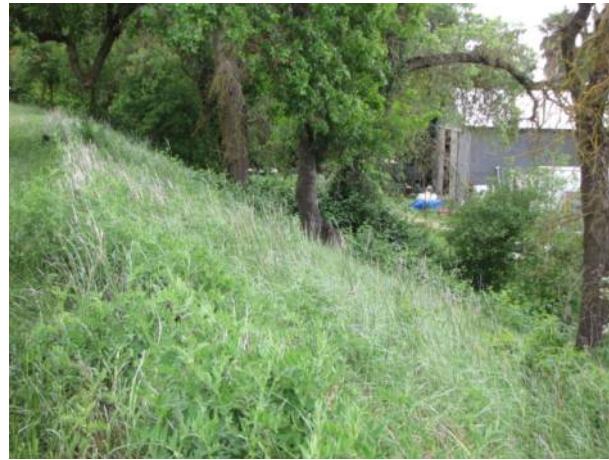
Levee Mile Report Line	25
Start Levee Mile	5.40
End Levee Mile	5.40
Location	Land Side
Category	Earthen Levee
Item	Vegetation
Looking downstream landside unsatisfactory growth slope shoulder and toe of levee section. 5-3-2012.	
phillips_s_20120515_421.jpg

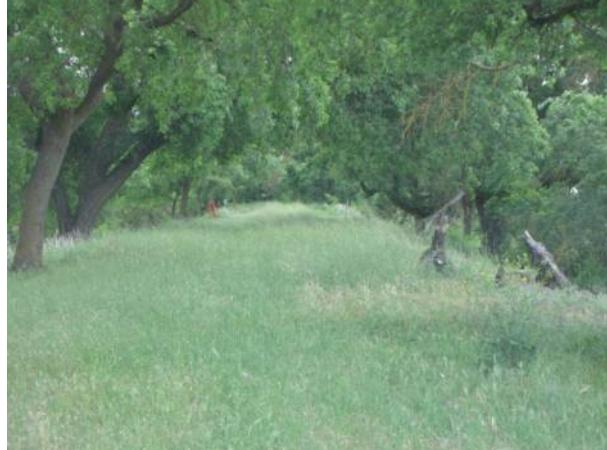
Levee Mile Report Line	26
Start Levee Mile	5.40
End Levee Mile	6.41
Location	Land Side
Category	Earthen Levee
Item	Crown Surface / Depressions / Rutting
Looking upstream crowroadway levee mile 5.40 overgrown. 5-3-2012.	
phillips_s_20120515_422.jpg

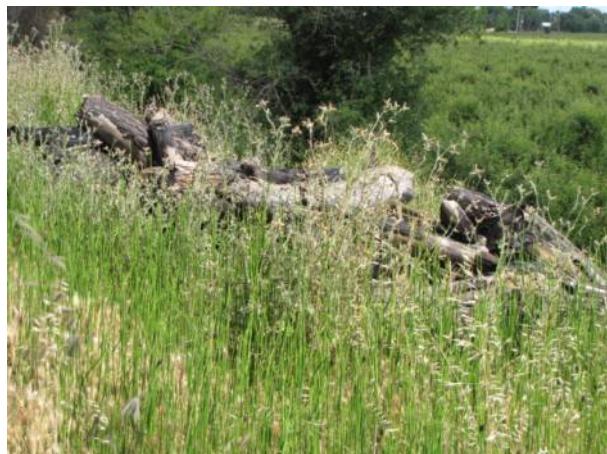
Levee Mile Report Line	27
Start Levee Mile	5.71
End Levee Mile	5.74
Location	Land Side
Category	Earthen Levee
Item	Encroachments
Firewood on levee slope not removed from fall inspection 2010. Photo taken 5-23-2011	
phillips_s_20120306_135.jpg
